## HP LaserJet P3005 Grinding Noise

Following in the footsteps of its predecessor, the P3005 has picked up a similar noise that is creating a lot of problems for techs in the field. One difference between the P3005 and its predecessor the LJ 2400 is the complexity of the problem.

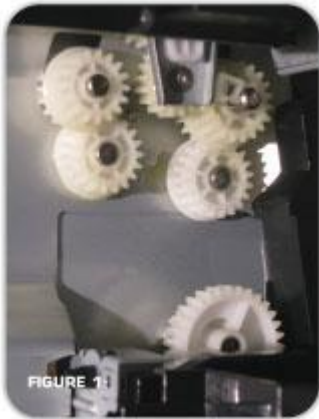
It starts in a familiar way: the fuser and the bushings wear out, allowing the lower pressure roller to sink down into the fuser. This allows the teeth of the drive gear to pull away from the drive gear to the fuser. As you would expect, when gears don't mesh properly, it leads to damage and "ouch!" we hear that same wonderful grinding noise. In some cases, it's a simple fix. But in other cases, a more complicated repair is needed. This issue will instruct you on 2 common repairs that fix the problem: the 4 gears that are attached to the fusing drive assembly and the delivery drive guides.

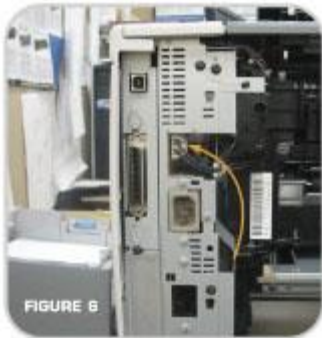
7. Disconnect the cables on the right hand side of the fuser. There is one purple and one yellow cable. (Figure 7)

8. Remove the four screws holding in the fuser. There are 3 self-tapping and 1 grounding screw.

9. Now tilt the fuser slightly towards the rear and pull it away from the machine.

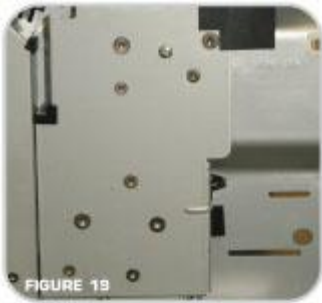
15. Output assembly exposing the last three possible gears to cause this noise. There are 3 gears and a pendulum assembly that you will expose. There is a 43-tooth gear (RU5-0955), a 31-tooth gear (RU5-0960) and a 65-tooth gear (RU5-0962) and a pendulum (RM1-3748). (Figure 22)

**Delivery Drive Gears** While not as common, there is another cause: the delivery drive gears. Three larger gears buried up on top of the delivery area, these are driven off of these four gears, by a pendulum gear that hangs down in between the two double gears. There is the pendulum gear, that sits over a big 65- tooth gear then you have a 43- tooth gear and a 31-tooth gear, that sometimes if replaced will take care of this issue. The 31- tooth gear is the gear that directly meshes with the output roller. We'll also give you instructions on how to replace these gears.

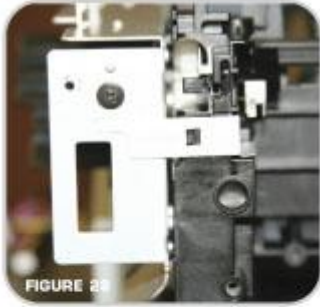
FIGURE 28

18. There is a metal strap that is held on by 1 screw on the rear of the machine that has to be removed. (Figure 28)
